ADVANCEMENTS IN PIGGING VALVE & ULTRASONIC TOOL TECHNOLOGIES ALLOW FOR IN-LINE INSPECTIONS OF FORMERLY UNPIGGABLE LINES

ABSTRACT

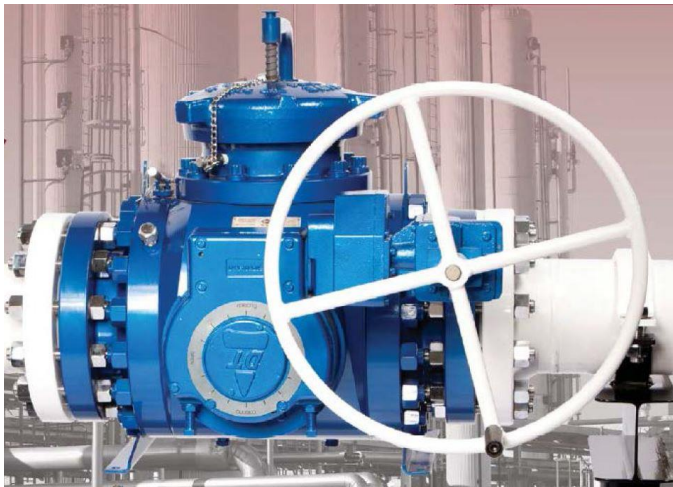
Figure 1: Argus Pigging Valve [5]

For most facilities, space is limited. Space used for 20-foot launcher and receiver barrels could be space used for additional assets for a terminal or space needed to complete facility maintenance. Another option is a 5-foot launcher barrel and receiver, but the traditional in-line inspection tools will not fit and would still require a complete skid install. In most cases, a launcher and receiver are not going to be practical to install inside a facility because operators would need multiple receivers and launchers for numerous lines. Argus valves, as shown in Figure 1, are an in-line solution which do not take up additional area. They can be installed in tight areas and need only small modifications to existing piping systems.

This innovative, double block and bleed valve has several benefits where it has the capacity to:

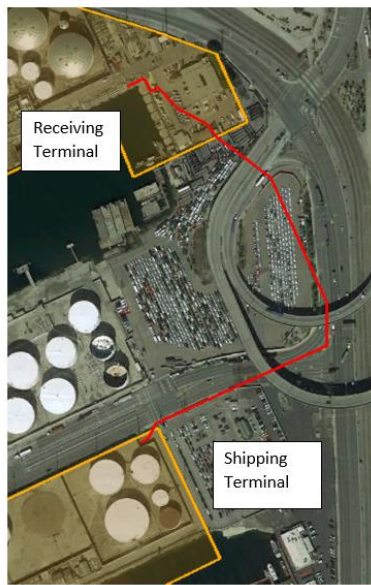
Figure 2: Selected line for Argus Valve Installation

The pipeline Andeavor selected is an 8-inch diameter line, installed in 1961. It transports oily water between two of Andeavor's facilities in California, as shown in Figure 2. It is 2,007 feet in length, with a Maximum Operating Pressure (MOP) of 720 PSI. The Normal Operating Pressure of the line, however, is only 50 PSI.

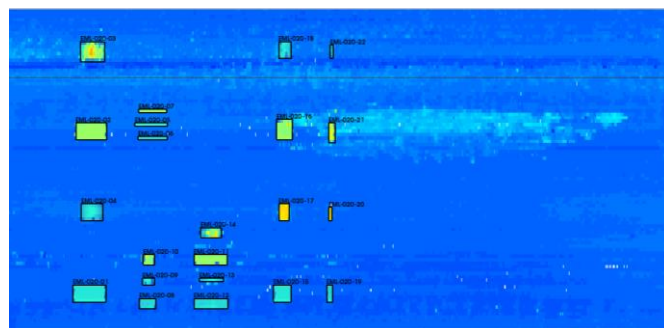
Figure 6: Inspection data for 8-inch single module tool matched the POI and POD capabilities of the proven 3-module tool.

Prior to the performance of the ILI inspection, a detailed review of the newly designed tool’s specifications and performance was performed. The 8-inch single module inspection tool was proven to accurately collect inspection data while operating within a pipeline featuring a pigging valve. This verification process was conducted by comparing the inspection data of the new 8-inch tool with the data collected by a standard 3-module ultrasonic inspection tool that exhibited proven defect detection results. Both ILI tools were run through a pipeline test loop with known defects. The 8-inch single module tool identified and measured all defects within the pipeline test loop and was verified by the inspection data collected by the proven 3-module ILI tool (see Figure 6).

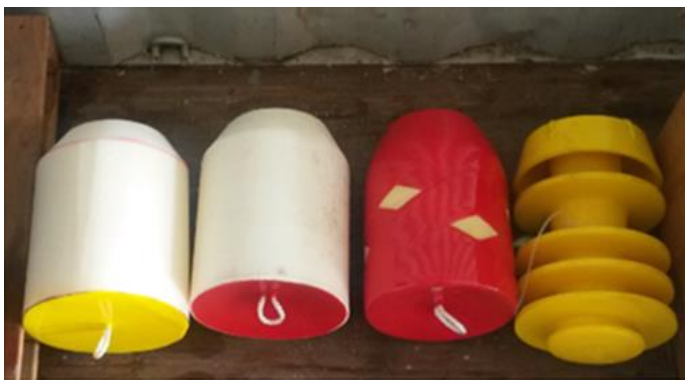
Figure 7: Maintenance Pigs

To test the functionality of the Argus pigging valves, and the passability of the line, Andeavor planned to initially run several maintenance pigs through the line. As shown in Figure 7 below, from left to right, the first two pigs were low density foam pigs, followed by a medium density foam pig, and then a poly pig. The first low density foam pig run yielded a torn, damaged pig saturated with oily debris. With every subsequent pig run, there was a reduction of debris in front of the pig. The photos of the runs were sent to Quest Integrity to verify that the line was ready for a smart tool. Once the poly pig (last pig on the right) emerged with acceptable abrasion and continued reduced debris in the front, Quest Integrity analysts were confident that the tool with 25% tool/ID clearance would pass. Line cleanliness was also examined and accepted by Quest Integrity to ensure the line was clean enough to obtain good ILI data.

This maintenance pigging practice was able to clean the line and remove about 50 years of debris build up, enhancing line integrity. This created a clean passage for the Quest
